VACATION HOME GERMANY

Niederzissen, Germany

Roof renovation with RHEINZINK GRANUM basalte

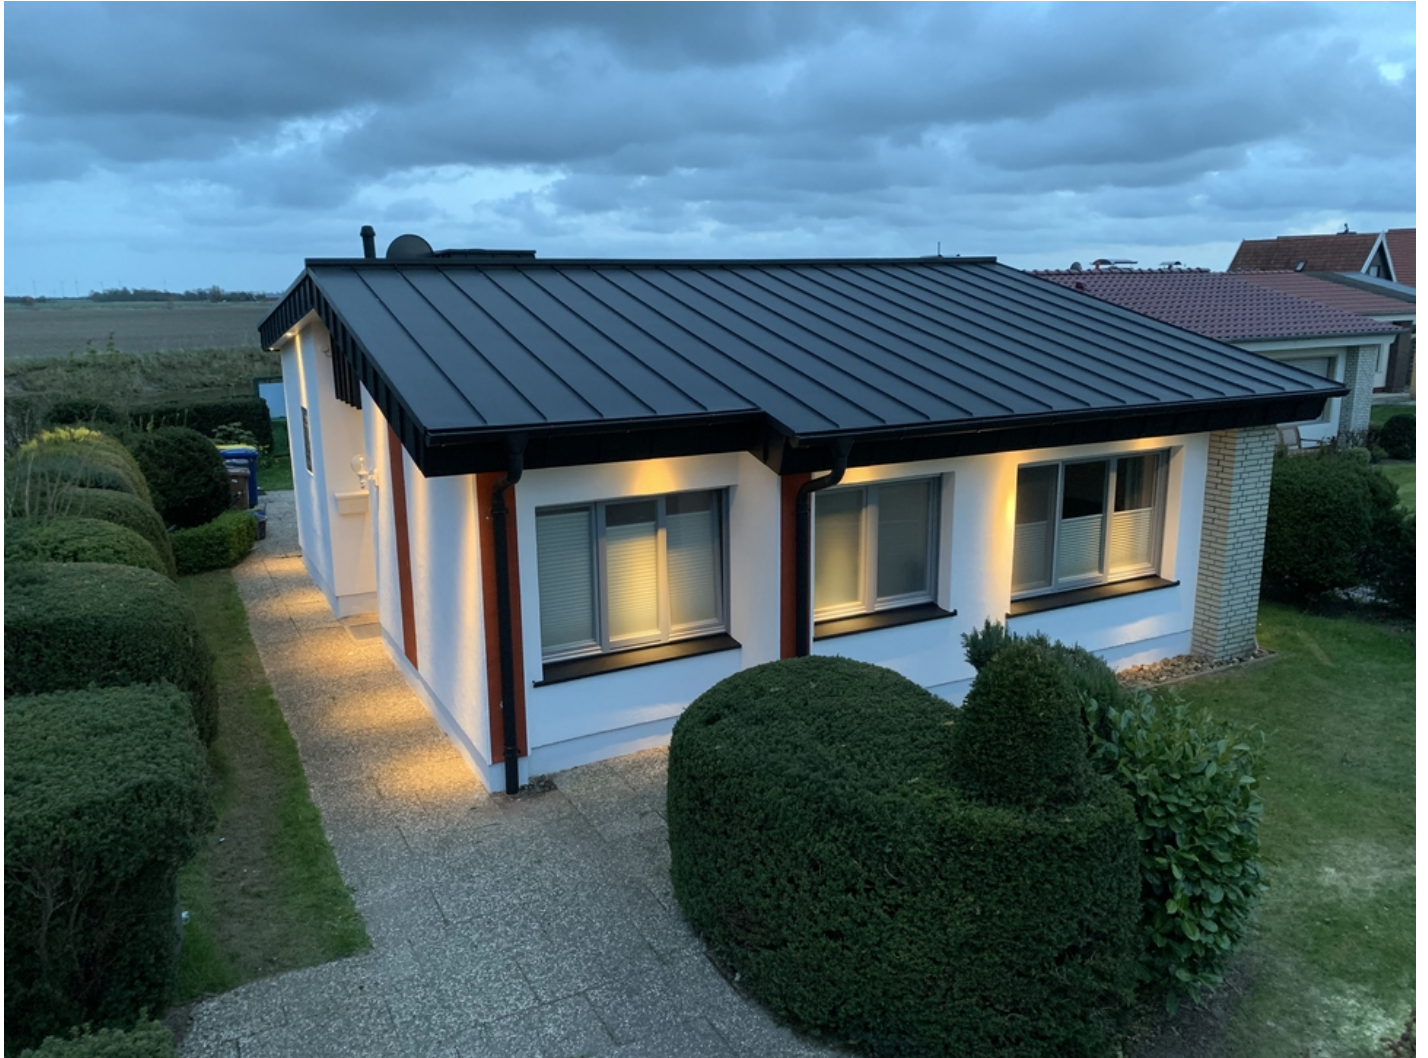
Toiture: Système à joint debout
RHEINZINK-GRANUM basalte

Évacuation des eaux pluviales:
RHEINZINK-GRANUM basalte

For the metal roof of a holiday home, the roofer used the new surface quality RHEINZINK GRANUM basalte for the first time. The carefully adapted roof layout and the precise roof division emphasise the noble appearance of the matt and deep dark material.
